Production rate of self-drilling soil nails in a coastal slope stabilisation project in Scotland

S. B. Mickovski,
Glasgow Caledonian University, Glasgow, Scotland

ABSTRACT: The aim of this study is to establish the production rate of self-drilling soil nails through different soil strata. To achieve this aim, the production rate of more than 800 self-drilling soil nails was monitored and recorded during a coastal slope stabilisation project in North-East Scotland. The recorded data was then analysed against the expected geology in order to establish the production rate in the varied soil types encountered on site which included: raised beach deposits of sands and silts, various cohesive strata comprising clays, and deeper granular deposits of gravel. The depth of installation of the soil nails ranged between 3 m and 22 m which allowed a determination of average production rate and standard deviation from the mean. The results showed that the production rate was the highest in the raised beach deposits, while most obstacles and refusals occurred in the deeper gravel deposits. The limitations of the production approach are discussed in light of the installation plant choice, the av

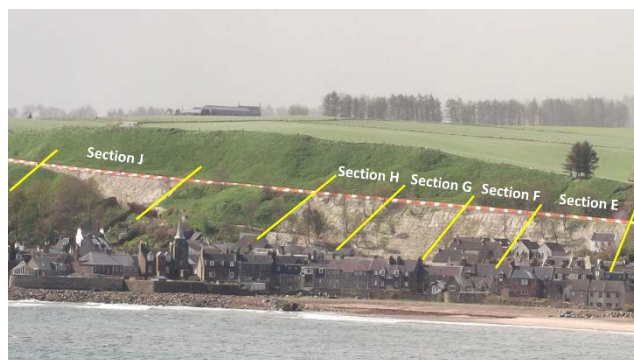
Figure 1. Site area with delineated soil nailing sections

The case study site is located in Stonehaven, northeast Scotland, forming the slope below the existing former trunk road (Bervie Braes Road), and including the adjacent coastal slope (Bervie Braes), as shown on Figure 1. The 40m high coastal slope above the old harbor in Stonehaven has a history of instability (Currie et al., 2009) which has resulted in the closure of the former trunk road bisecting the slope. The road runs sidelong and generally northwest-southeast across the Braes. For this case study, only the soil stabilization works carried out on the slope below the Bervie Braes road ('Lower slope' on Figure 2; Mickovski 2014b) will be considered.

Due to the limited budget available for the works and the available timeframe for completion of the project, the slope stabilization design comprised self-drilled hollow bar soil nails which were preferred to solid bar soil nails (Mickovski et al 2013, Mickovski 2014b). The design included soil nails with lengths of between 7 m and 24 m. The spacing between the nails was 1.5 m horizontally and 1.0 m vertically. The scope of the stabilization works was to provide the necessary resistance to erosion, shallow and deep seated (active zone of up to 10 m depth) slope failures. The design was developed based on characteristic ground profiles in five different sections of the site (Sections E-H, Section J; Figure 1), and comprised the installation of approximately 1700 self-drilling hollow bar soil nails.

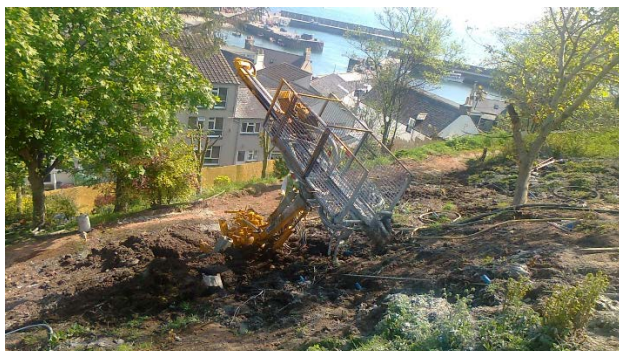
Figure 3 Soil nailing rig positioned on site. A short section of soil nail can be seen on the slope in front of the rig.

The soil nails installed in this case study comprised a 38 mm external and 19 mm internal diameter (753 mm² cross-sectional area), galvanised steel bars in mainly 3 m long sections, coupled together using galvanised steel couplers to achieve the design length and progressed using a sacrificial bit drilling a 100 mm diameter hole. The access to each nail location was cleared of vegetation and the drilling rigs were positioned at each location ensuring the safety and stability would be maintained during the construction (Figure 3)

A total of 1678 nails were installed using an Atlas Copco ROC 460 rig with an air flush through the Raised Beach Deposits, Glacial Sands and Gravels and into the Glacial Till where the majority of the design bond lengths are located. The holes were progressed using grout flush, with a continuous recording of injected grout volume and pressure. The installation of each nail was carried out by a team of two drillers, supervised by a suitably qualified geotechnical or civil engineer who, above and beyond the requirements specified in BS EN 14990:2010, recorded the time needed for installation of each section of nail tendon and scheduled material testing in accordance with the Quality Assurance and Quality Control standards.
